## *Mazda Service Bulletin*

MAZDASPEED3 (Axela), MAZDASPEED6 (Atenza), and MPS  
Service Bulletin v1.20

11/5/2012

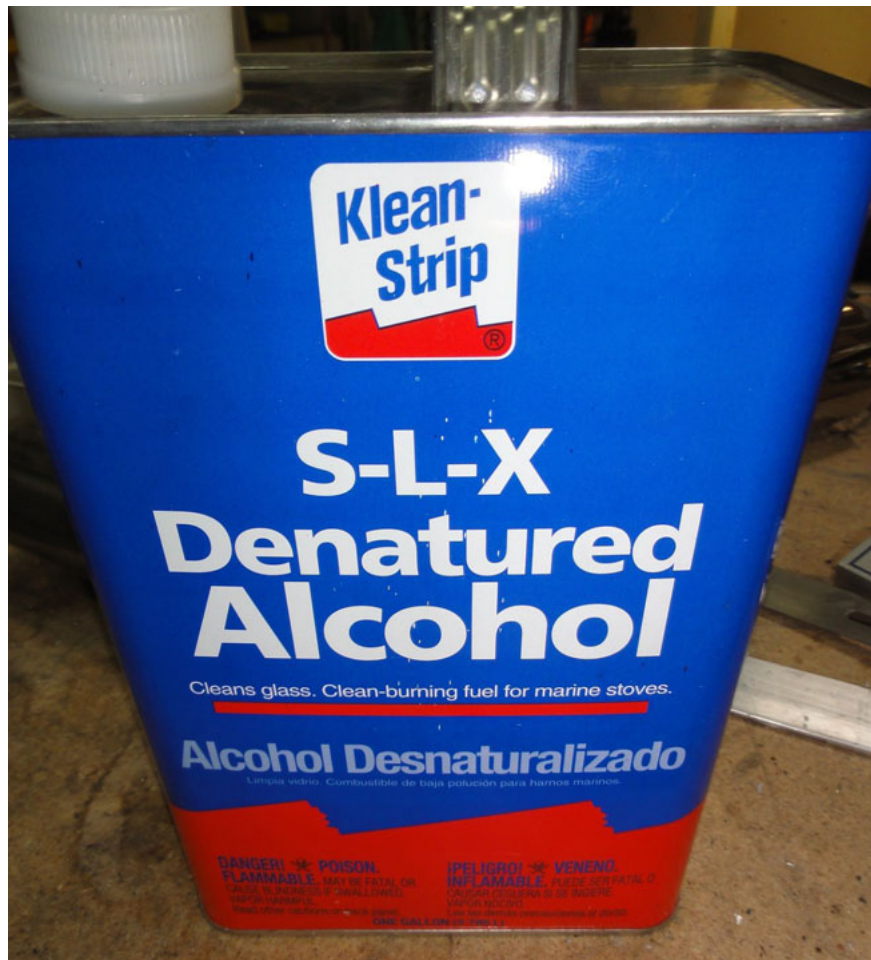
- I. Denatured Alcohol – Had the strongest effect on the build up. It most effectively turned the solution inside the port into a homogenous liquid saturated with the carbon build up. When scrubbed and siphoned away, the alcohol removed the most build up with each subsequent “soak”.

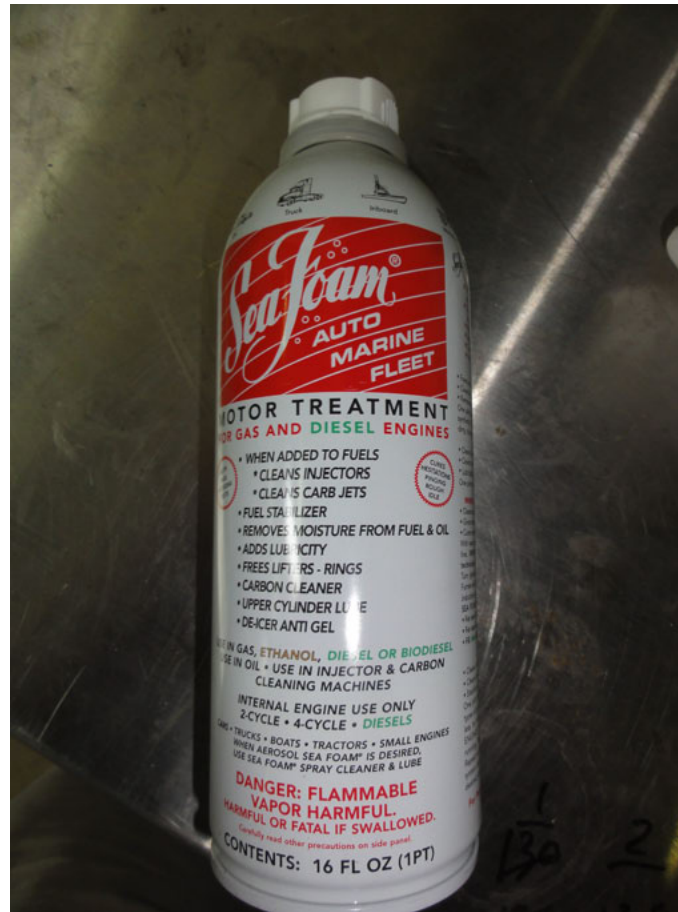
- II. Sea Foam – Had a strong effect on the build up but, unlike the alcohol, did not dissolve the build up as much as it broke it down into a removable “goop” that could be scraped from the port. Unlike any other solution, the Sea Foam allowed me to scoop up material that would stick to the tools.

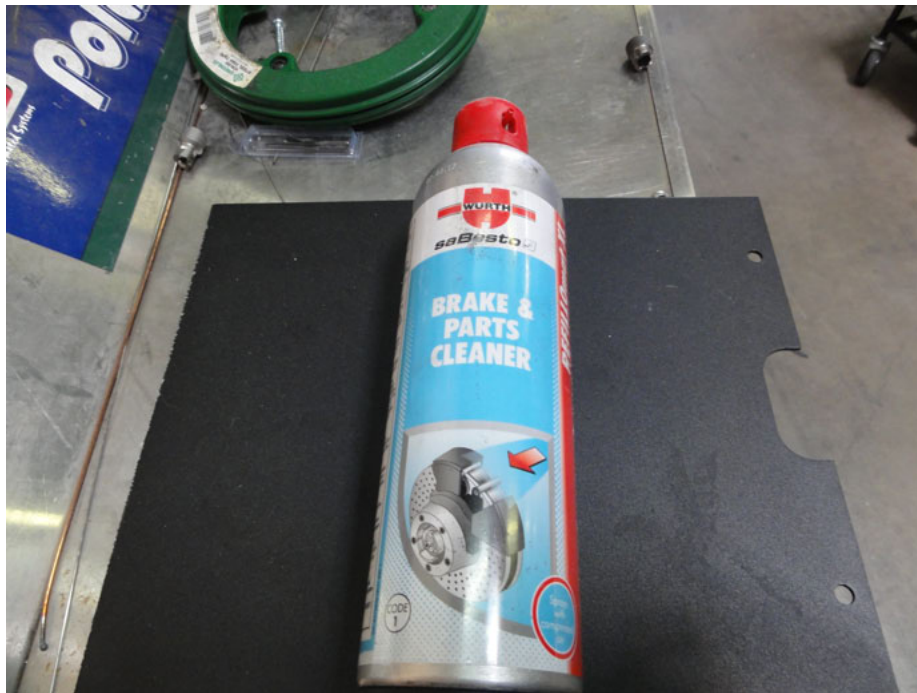
III. Brake & Parts Cleaner – After soaking and scrubbing, the siphoned liquid from the port was obviously saturated with carbon material, but the overall effect it had on the valve surfaces was minimal compared with the alcohol and Sea Foam. The cleaning ability is similar to carburetor & choke cleaner.

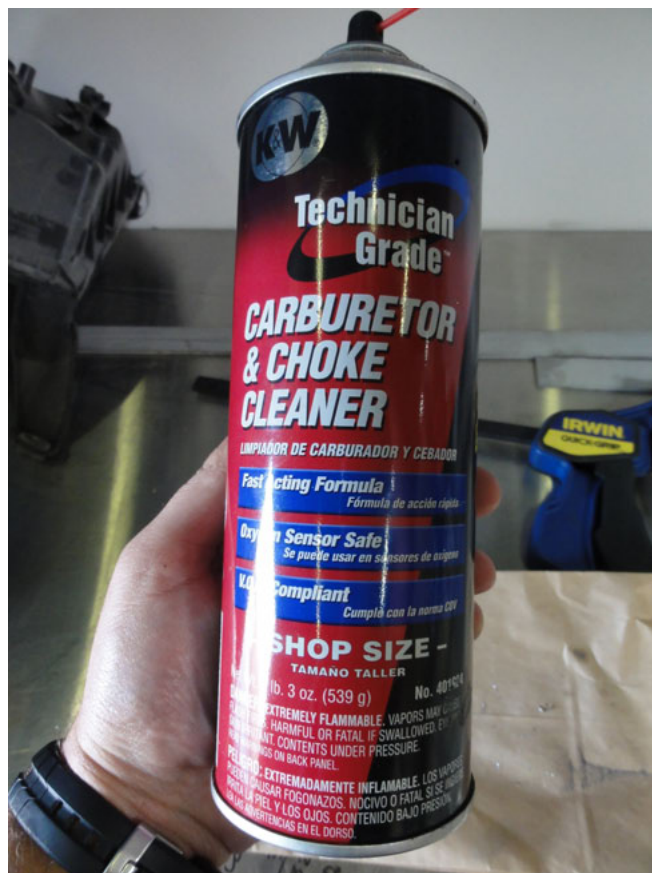
IV Carburetor & Choke Cleaner – After soaking and scrubbing, the siphoned liquid from the port was obviously saturated with carbon material, but the overall effect it had on the valve surfaces was minimal compared with the alcohol and Sea Foam. The cleaning ability is similar to brake & parts cleaner.

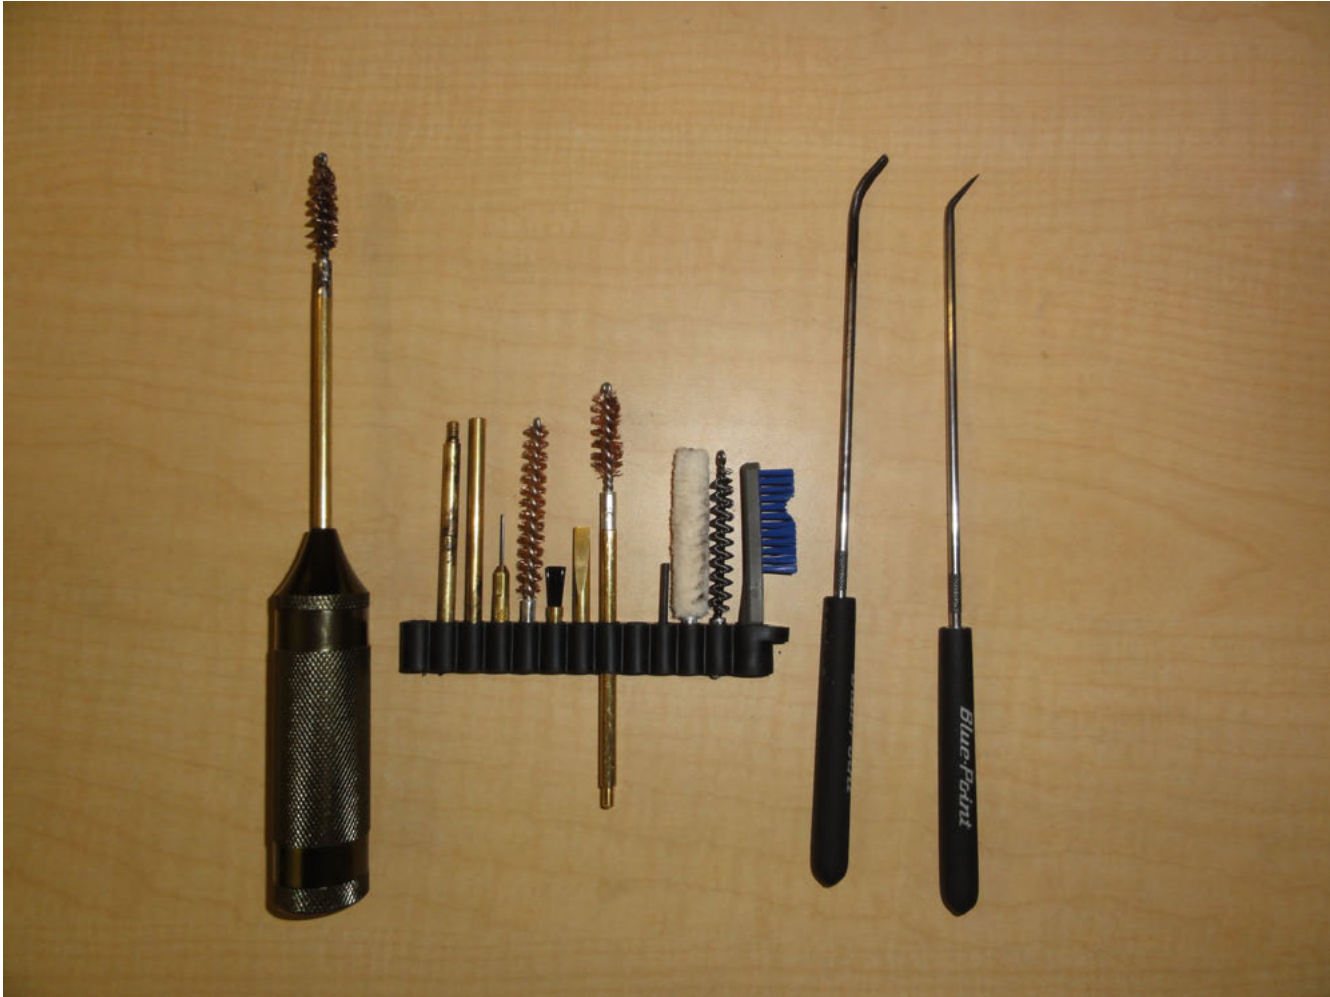
All the valve ports received at least 15-20 minutes of vigorous picking, scraping, and scrubbing with a combination of all the solvents. Please be sure to not scratch the valve shaft surfaces too far above the valve head, as this is where the valves glide inside the valve seals and a scratched valve shaft surface may cause premature wear of the valve seal. This caution also goes for the bottom of the valve head where the precise machining to match the valve seat takes place.

In the end, the valves in no way resemble a new part, but we can state that they were sufficiently cleaned for the task at hand. We were able to remove a large majority of the hard and soft build up on the valve surface, leaving only the most stubborn build up. With more time, we are confident that the remaining build up could have been removed, as well.

To physically clean the valves, we used a combination of gun cleaning tools, consisting of various picks and wire brushes to agitate and remove the carbon buildup. The pick tool comes in handy when attempting to remove build up on the back side of the valve. Some bending/flattening of your tools may be necessary to better accommodate the job.
